R E P O R T

To:	Community Heritage Commission	Date:	November 4, 2020
From:	Kathleen Stevens, Heritage Planning Analyst	File:	HER00769
Subject:	221 Townsend Street –Heritage Revitaliza	tion Agre	ement Application

Heritage Conservation Plan

221 Townsend Place, New Westminster BC :: Edmund C. Davey House

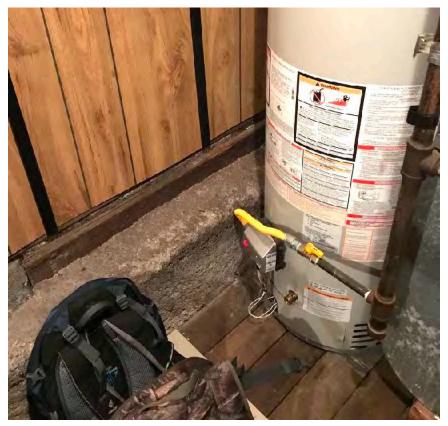
The visible portions of the concrete foundation on the interior appear in **good** condition, but a full assessment of the foundation is not possible as the basement walls are finished to the ground as is the exterior cladding. There is evidence of a slight sinking the northeast corner of the house. The basement floor has been dug down internally close to 2' lower than grade, below the main house, but not below the front and back porches. This makes for an inconsistent basement ceiling height and raises questions about the integrity of the foundation perimeter and perimeter drainage. Based on early 1900s wood frame houses, it is unlikely that the wood structure is safely secured, if at all, to the concrete foundation. For all these reasons, the foundation condition is considered unknot and likely seismically and structurally insufficient.

Section of foundation as visible from inside the mechanical room, east side.

At this time it is assumed the foundation will need to be completely replaced. However, the first step to confirming this is to gut the basement interior finishes and expose the entire foundation and slab. Once confirmed that the foundation/slab are not adequate, consistent, seismic or salvageable, excavate the entire foundation area and pour a new insulated, seismic concrete foundation.

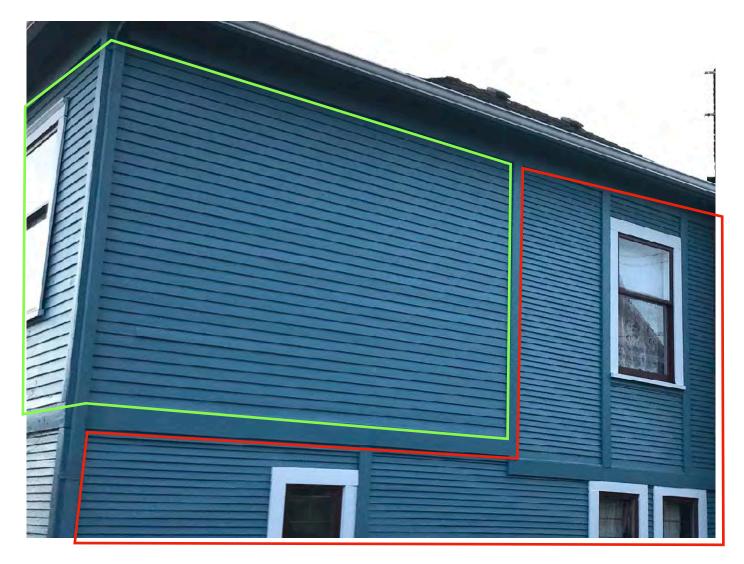
The wood-clad panels and the vertical battens that cover the joints between them, are in **good** condition. The wood soffits, corner and water boards and all the windows and door trim boards are also in **good** condition. There is no evidence of individual elements that are damaged beyond repair.

There are two dimensions of bevelled siding on the building, the more narrow 1907 cladding (outlined in red on the above photo) and a slightly wider board used for the porch enclosure and extension of the front (outlined in green). These different dimensions are evidence of the intervention in 1931 and mark where the original design H ends.

Preserve in situ the wood-clad panels and vertical battens that cover the joints between them on all four sides of the house. Preserve the wood soffits, corner and water boards and all the windows and door trim boards, except where alterations are proposed as defined on the Building Permit drawings. The known alterations are mostly concentrated on the least visible elevation of the building, the yard-facing west side, where two windows openings had already been changed from their original state and where a new second story verandah and a bike storage structure are proposed:

If and where any exterior wood element is identified as damaged beyond repair, replace it inkind with a replicated wood element of the same dimension and profile.

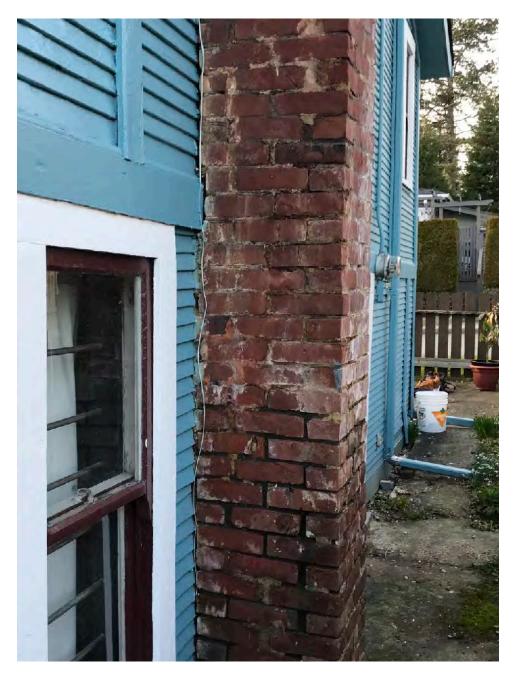
The end wall chimney added in 1913 is in **poor** condition, showing evidence of moisture in the mortar joints, the use of incompatible mortar and structural failure. The chimney is separating from the building.

Remove 1913 chimney for its deteriorated condition, obsolete function and misalignment with the Design H chimney location. Restore red brick chimney stack on the western roof plane as per the Design H sketch and the Building Permit drawings.

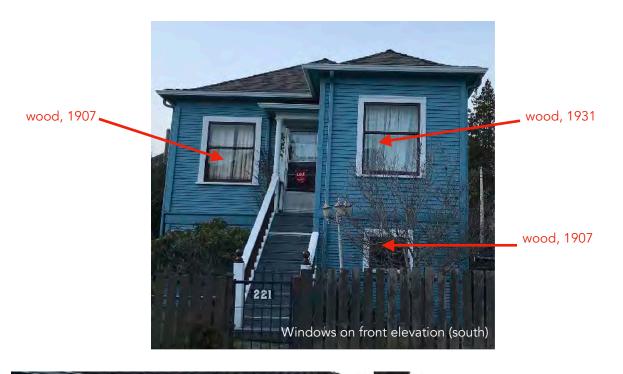
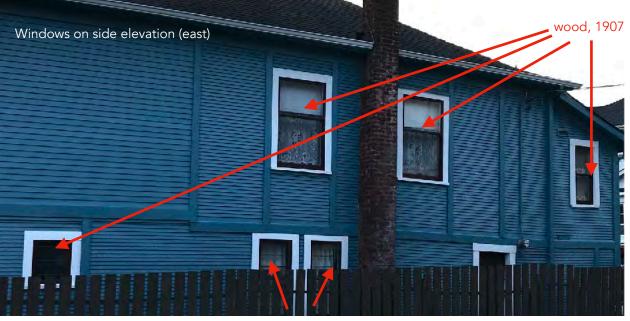
Most of the windows are original, double-hung or fixed wood windows dating to 1907, three double-hung horned wood windows date from 1931 and three are newer, incompatible vinyl inserts. All windows, wood and non, are in **good** condition. All the windows have projecting wood sills, which are all in **good** condition. Some of the double-hung wood windows require repair and maintenance (weight rehanging, putty and paint repair). See additional photos on next page.

wood, 1931

Preserve the following windows by working with a professional window restorer to repair, rehang, repaint and improve the operability of the original sashes:

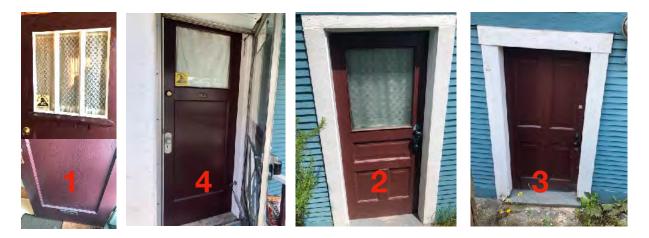
- 1. The early front wood front door, likely dating from 1931, is in *good* condition.
- 2. The 1907 basement wood door on the west elevation, is in *good* condition.
- 3. The repurposed interior wood door on the basement east elevation is in *fair* condition.
- **4.** The early back wood door, possibly dating from 1907, is in **good** condition.

The wood front porch, having been reduced in 1931 to a very minimal stoop, is in **good** condition but has an extremely inadequate landing size. This is one of the reasons the front door can't be photographed from in its entirety (see above photo).

Front porch: Rebuild in wood following a design typical of Edwardian cottages of this era, which will allow for a larger porch landing and one half-way stair landing. This proposed compatible stair enclosure addresses the inadequate 1931 front stair and landing design. Clad stair enclosure with slightly wider lap siding that matches the 1931 exposure as present on the front elevation, upper storey.
