Subject: 404 Second Street (Queen's Park Meat Market): Heritage Revitalization

Heritage Conservation Plan

Queen's Park Meat Market - 1926 402 - 404 Second Street, Queen's Park - New Westminster, BC

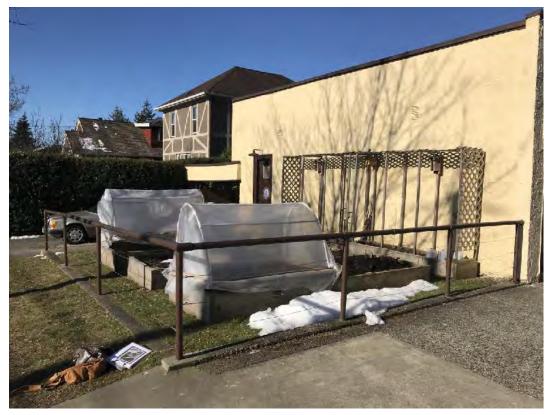
Fourth Avenue elevation. Visible are the original concrete foundations of the 1926 store when it was closer to the corner.

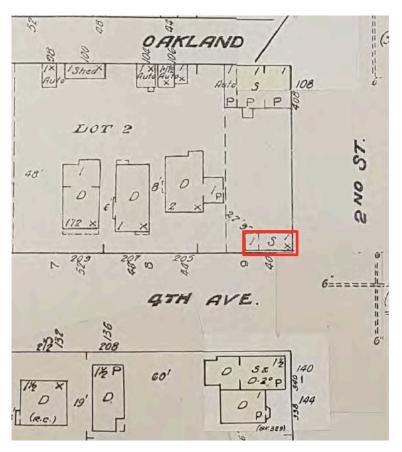
Above: The partial view of a 1913 fire insurance map for New Westminster, shows the bakery building at the corner of Second Street and Fourth Avenue, which was replaced by the Queen's Park Meat Market building in 1926 (red). It also shows the 1896 building and the Model Bakery (408 Second Street) on Lot 9, the Fred Mark House on Lot 8, and the store and house at 340-342 Second Street (green).

Left: The partial view of a 1931 fire insurance map for New Westminster shows the meat market store as a single storey wood structure right at the property lines (red) as well as evidence of the other mentioned stores above and below marked with the letter 'S', indicating the small commercial strip which was present here in the first several decades of the 20th century.

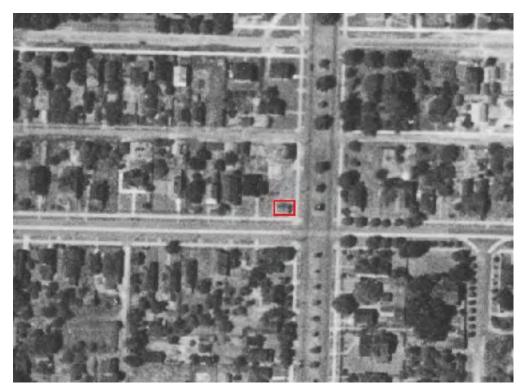
This partial view of a 1928 aerial photograph below shows the Queen's Park Meat Market at the exact location of the former bakery building (red). The aerial photograph also shows that by 1928, the 1896 building previously located at Lot 9, was relocated to its current site at the adjacent lot 8, now 205 Fourth Avenue.

Left: partial view of an aerial photograph of New Westminster - 1928.

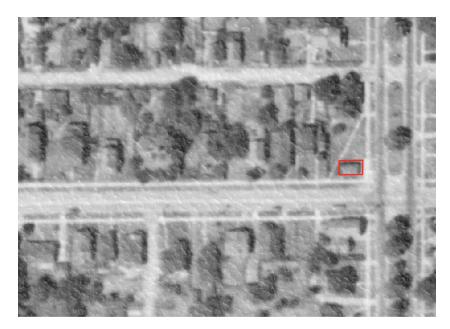
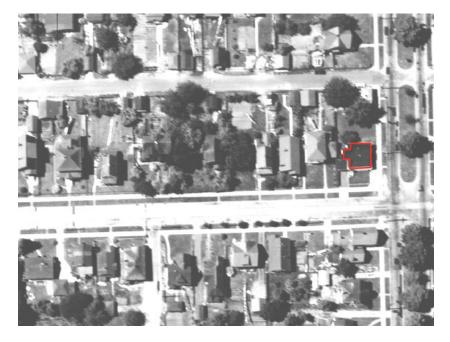
A comparison between an aerial photograph from July 1950 and one from later in the 1950s (exact date unknown), shows that the Queen's Park Meat Market was altered and relocated in the 1950s. The butcher shop was most likely relocated as part of the major alteration by the Whyte family involving the addition of living quarters in 1951. The aerial photograph of July 1950 shows the butcher shop at its original siting right at the corner property lines (red). The photograph from a later date shows the original location of the butcher shop vacant (although the concrete footings are still visible in the photograph, as well as on site today), and its current location further north (red).

Left: partial view of an aerial photograph of New Westminster - July 1950.

Left: partial view of an aerial photograph of New Westminster - 1950s.

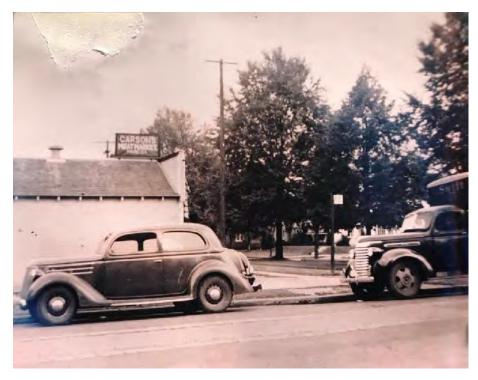
Left: a 1938 photograph of the Queen's Park Meat Market, then known as Carson's Meat Market. The picture shows the building at its original siding at the corner, facing Second Street.

The wood-clad building featured a light paint colour; a false fronted facade; a shingled gable roof; a small chimney; and a Carson's Meat Market sign.

Roof sign - restoration - Restore rooftop sign as per 1938 archival photo. Business name can be current or Queen's Park Meat Market. The construction of the sign should include a black metal frame attached to the roofline. The sign itself should also be of a durable material, such as aluminum, but removable in case of a business name change.

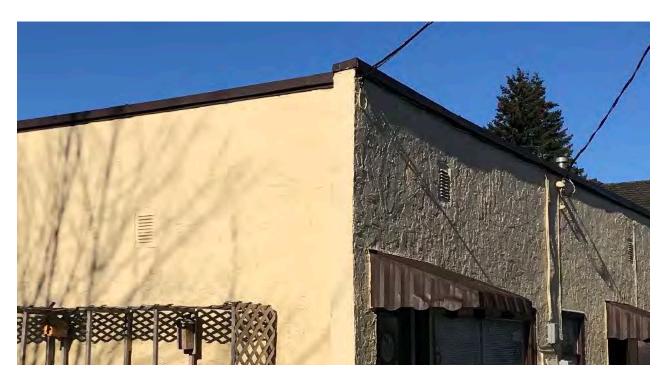
Roof and roofline coping - The building's flat roof was not accessed or viewed as part of the condition assessment. The roof was redone approximately 10 years ago (2010) and is in functional condition.

The roofline is clad in a wood facia, capped by a metal coping. The metal coping appears to be in good condition but the paint on the wood facia is peeling in places. A closer examination of the joints in the metal coping should be taken on upon construction commencement as well as that of the wood facia.

Roof and roofline coping - preservation. Upon construction inspect roof condition and closely examine metal coping condition and joints. Conduct any maintenance or repairs at that time.

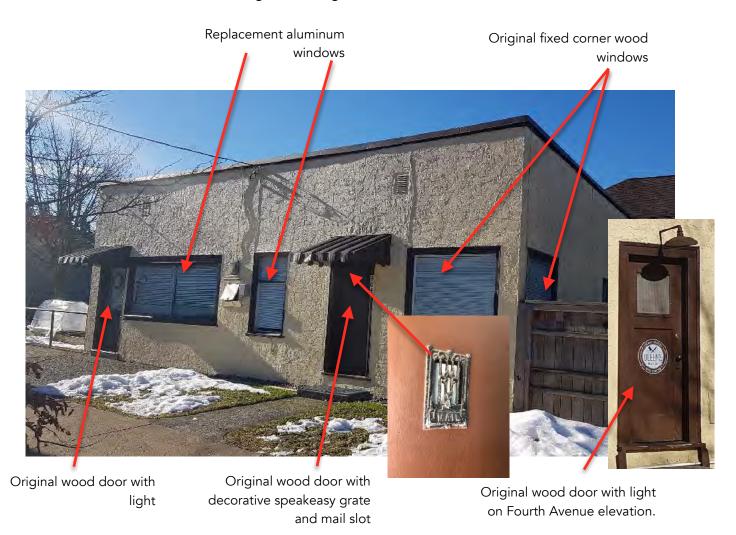
Aluminum strip canopies - The two 1951 aluminum strip canopies above the facade doors are in good condition.

Finishes - The painted finish on all wood elements (door and window trim, doors, windows, and roofline facia) is all in fair condition - i.e. flaking, dry and in need of a thorough repainting. The original 1951 paint layers identified on the building are as follows:

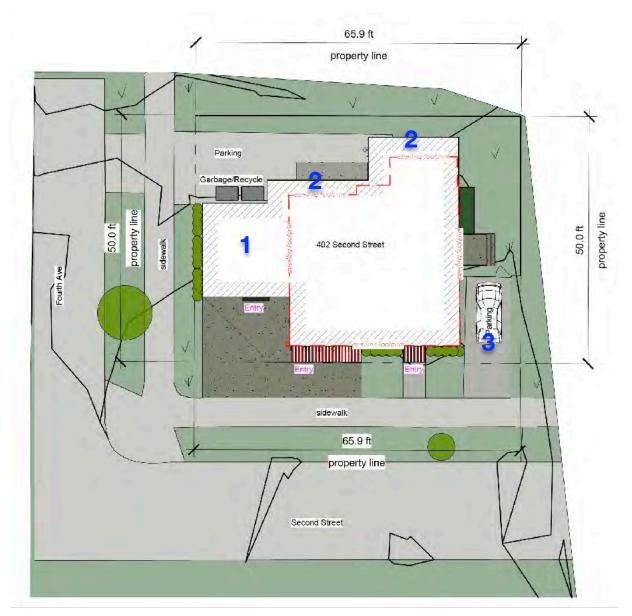
Site plan below shows existing building footprint in red and proposed in black.

The property will be rehabilitated for improved and sustainable use, involving an addition to the store (1), to be sited on the historic site of the store before it was relocated to its current in 1951; a basement level to the building (not visible on the site plan nor from the street as it will be underground and within the proposed footprint) providing new freezer, storage and prep areas for the meat market; a slight extension at the rear (2) where no Character Defining Elements were identified; and a new off-site parking pad for the residential component (3).

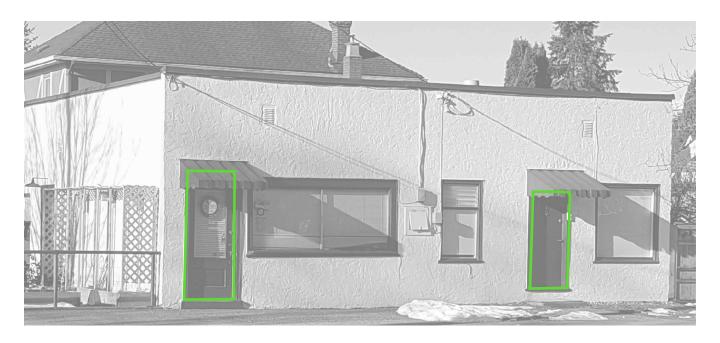
Wood windows - preservation and restoration

Adjust commercial window sill height to align with residential window height. Although the residential and commercial window sills will now align on this elevation, they are still perceived as distinct in scale and purpose. All sills should be wood and projecting as well as extending. Restore wood sashes where currently there are aluminum sashes as per the sash width on the wood corner windows.

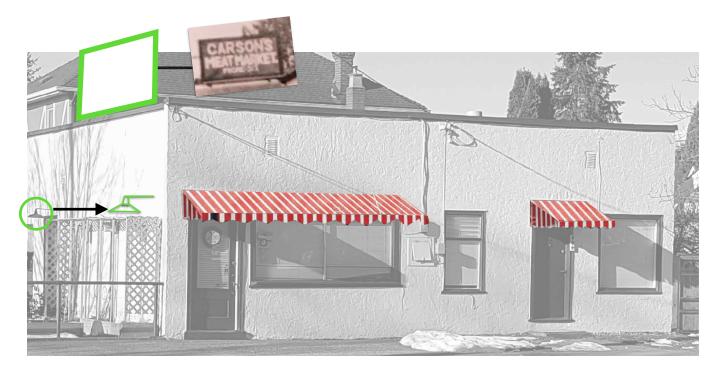
Aluminum strip canopies - preservation and rehabilitation. Extend commercial awning across commercial windows by custom-building a replica. Note, this is an original aluminum awning with vertical appliqués. Preserve original awning above residential door. Repaint in contrasting red and white stripes, traditional for meat markets awnings.

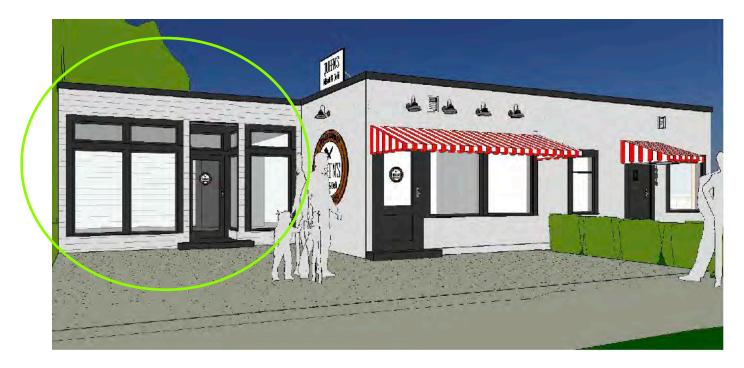
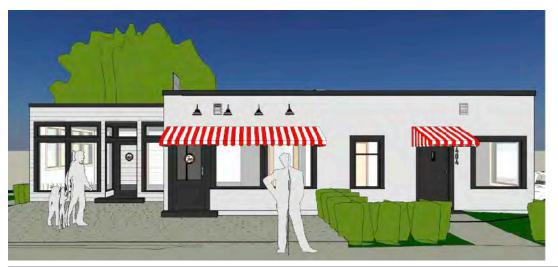
A set-back store addition/extension is proposed on the Fourth Avenue elevation, as is a non-visible basement level below the entire structure. The highly visible store addition is justified to expand the currently insufficient retail space and separate it from the storage and prep space, which will now be mostly located in the basement. It aligns in its simple flat-roofed form and modest height with the historic store building, but as it is located on the former site of the 1926 store, it takes inspiration from the recorded finishes (see archival photo on page 18) of the earlier store before its relocation - horizontal siding. Otherwise, its two primary facade designs conform with traditional storefront compositions, but applying contemporary modern, metal or metal clad window assemblies, so as to distinguish it as a contemporary addition. With the above mentioned features the addition meets the requirements for additions to historic places to be 'subordinate to, compatible with and distinguishable from' the historic place.

The proposed store and addition, retain the flat roof, modest neighbourhood store character the historic place is recognized for today.

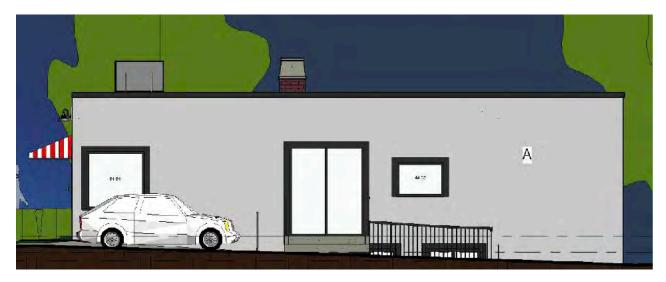
Side elevation

The original wood window closest to the facade elevation will be preserved in situ. The other openings on this elevation are new, and can thus be distinguishable in a contemporary material such as metal or metal clad doors and window. All door and window trim on this elevation to be compatible with the historic trim style and dimensions as detailed on page 31.

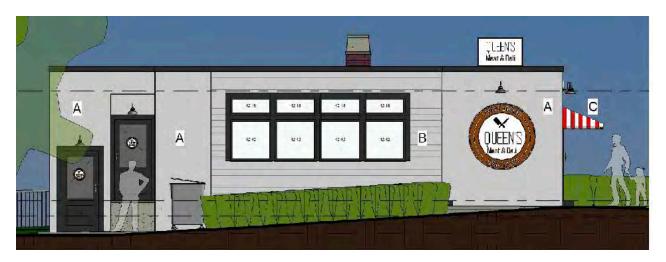
Fourth Avenue elevation

An original partially glazed wood door will be preserved on this elevation with its original hardware and trim set. Traditional painted signage and documented roof signage will be visible on this elevation. New storefront windows and entry door will follow guidelines for additions as per page 34.
