R E P O R T

To:	Community Heritage Commission	Date:	November 4, 2020
From:	Kathleen Stevens, Heritage Planning Analyst	File:	HER00769
Subject:	221 Townsend Street –Heritage Revitaliza	tion Agre	ement Application

Heritage Conservation Plan

221 Townsend Place, New Westminster BC :: Edmund C. Davey House

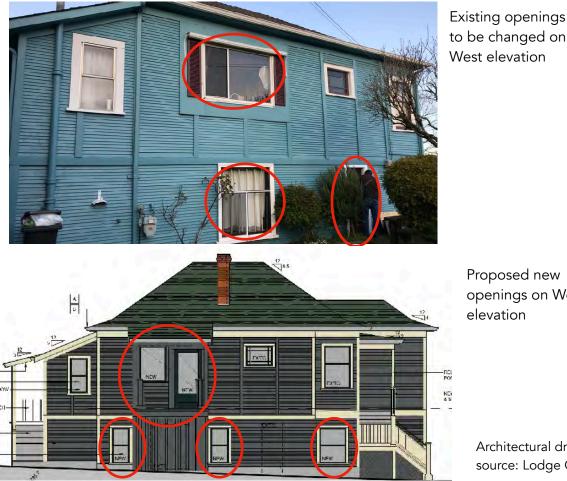
Proposed new openings on West

Preserve in situ the wood-clad panels and vertical battens that cover the joints between them on all four sides of the house. Preserve the wood soffits, corner and water boards and all the windows and door trim boards, except where alterations are proposed as defined on the Building Permit drawings. The known alterations are mostly concentrated on the least visible elevation of the building, the yard-facing west side, where two windows openings had already been changed from their original state and where a new second story verandah and a bike storage structure are proposed:

If and where any exterior wood element is identified as damaged beyond repair, replace it inkind with a replicated wood element of the same dimension and profile.

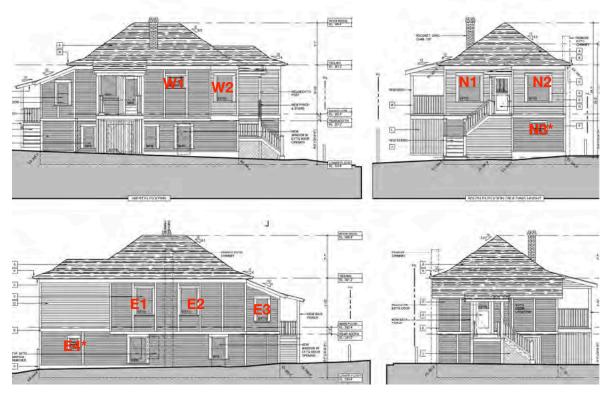
Preserve the following windows by working with a professional window restorer to repair, rehang, repaint and improve the operability of the original sashes:

* **NOTE:** Remove basement level windows and doors before house lifting (sashes only - leave frames in place) to avoid damage. Repair and reinstall after the house is back in place.
